# MINE SAFETY INVESTIGATION UNIT

INFORMATION RELEASE

## Fatality

<b>Incident date</b>	21 May 2014
<b>Event</b>	Worker crushed while using mobile elevated work platform
<b>Location</b>	Boggabri Coal Mine, Boggabri NSW

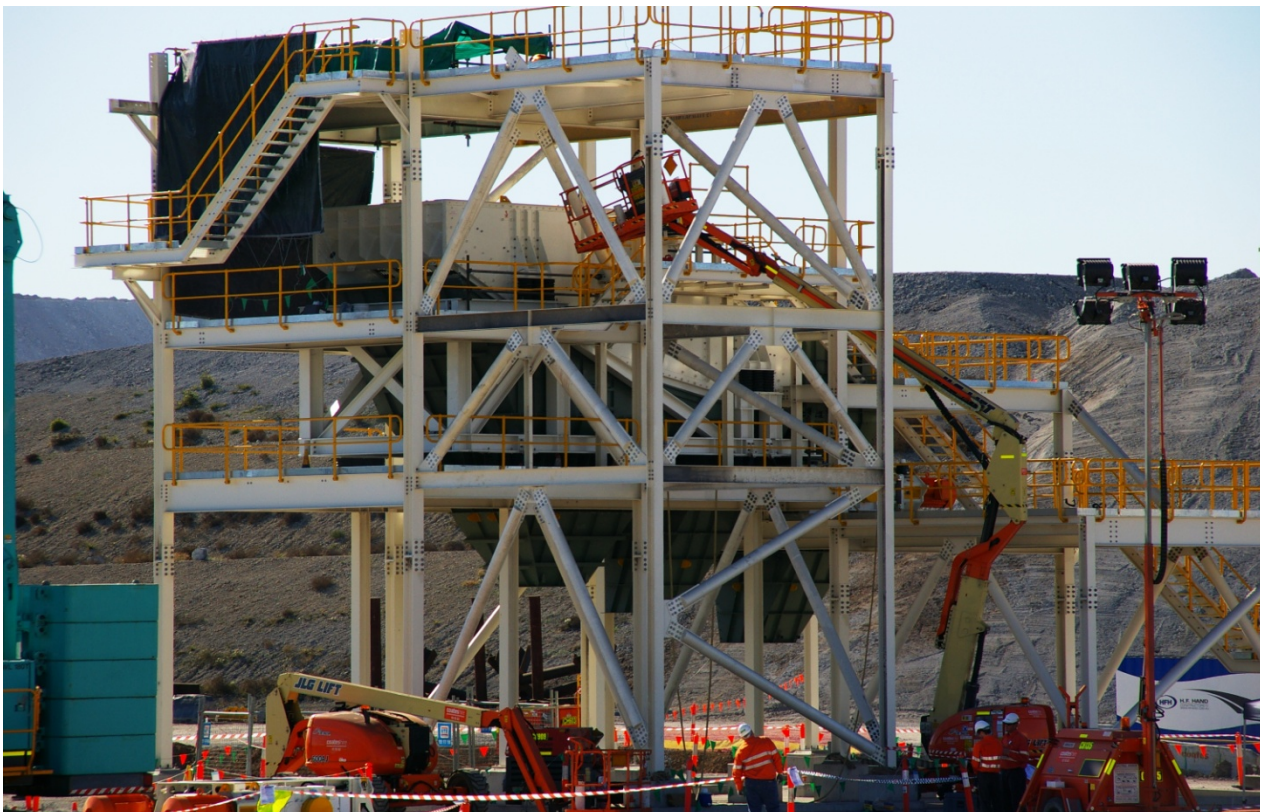
A construction worker was using a mobile elevated work platform (MEWP) within a steel structure when his head was crushed between the protective rail of the MEWP work basket and an overhead steel beam about 14 metres above ground level. Investigations into the incident are continuing.

Steel structure with MEWP in approximate position (after recovery of worker) - *Photograph by Investigation Unit*

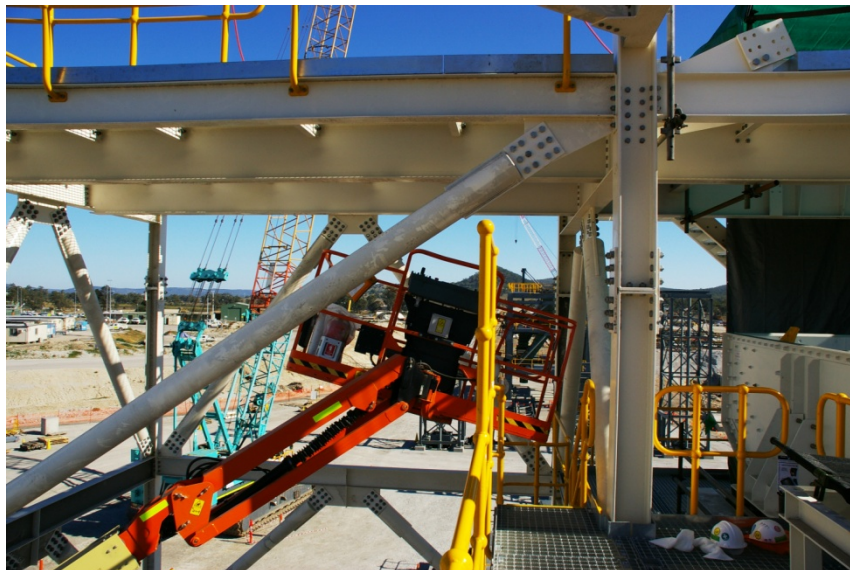
Position of MEWP basket (after recovery of worker) - *Photograph by Investigation Unit*

The base of the mobile MEWP was on a concrete pad at the base of the building. The basket had been positioned centrally within the building, and underneath the upper floor level. The articulated boom had been manoeuvred to reach in between the structural elements of the building.

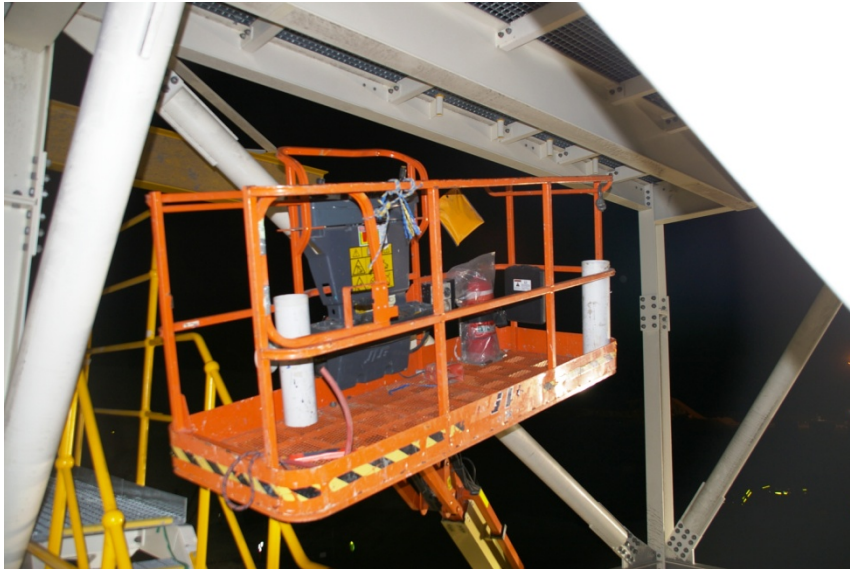
The beam directly above the MEWP basket projected 600 mm into the space below the top floor, and 300 mm deeper than the next beam forward of the position of the operator.

600 mm beams directly above MEWP basket (after recovery of worker) - *Photograph by Investigation Unit*

At the time of the incident the deceased worker was observed standing alone in the MEWP basket. When last observed by a worker, there was only a small distance between the worker's safety helmet and an overhead 600 mm steel beam.

Shortly afterwards, the deceased worker was seen with his head caught between the steel beam and the safety rail protecting the operator's console.

In response to this incident, Mine Safety inspectors issued the mine operator with a notice requiring a full risk assessment to be undertaken in relation to all MEWPs at the site. The notice also requires the mine operator to consider the use of engineering controls that provide overhead protection for operators working in MEWP baskets.

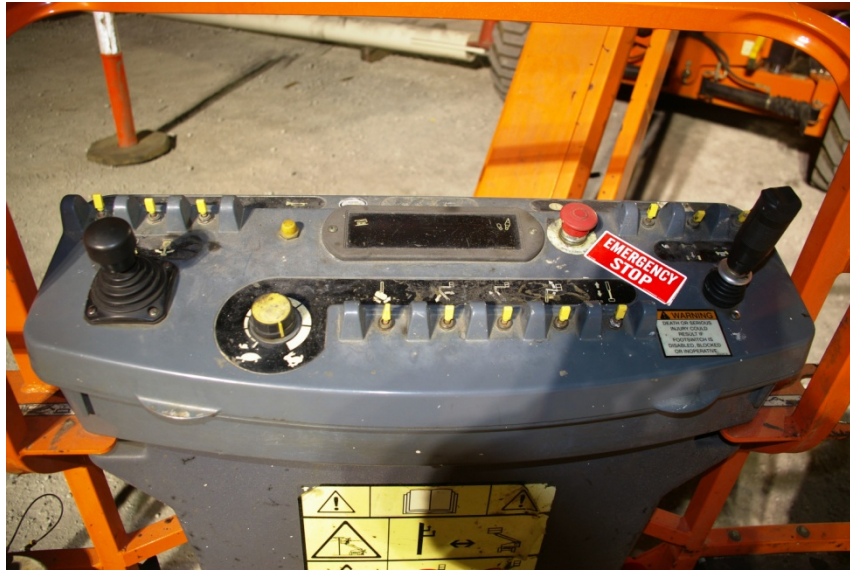
Control console on a similar MEWP basket - *Photograph by Investigation Unit*

A guard rail was positioned above the operator's console, intended to safeguard the console and control levers from being struck by any obstructions in the work zone. This can be seen at the extreme upper edge of the above photo.

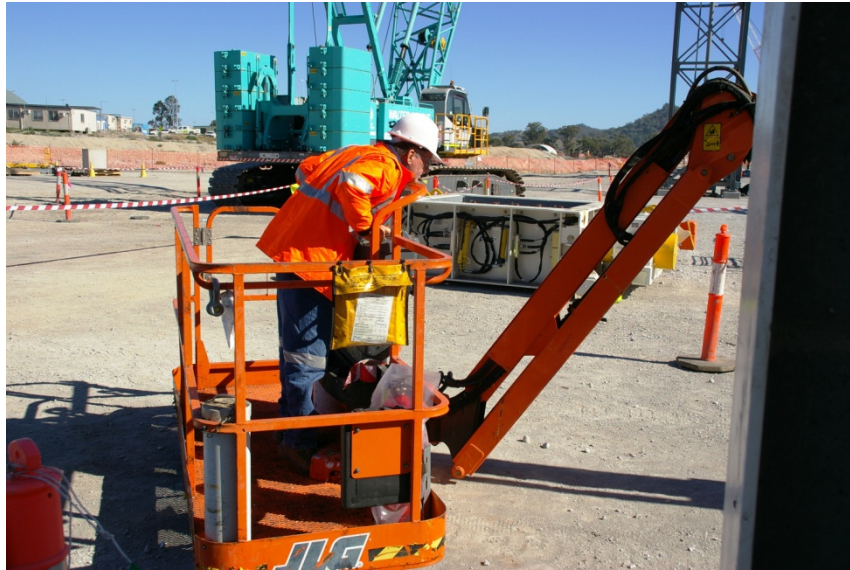
The following photograph depicts a ground level simulation of the approximate positioning of the deceased worker in the MEWP as observed by a worker at the time of the incident.

Simulation showing position of the worker in the MEWP at time of incident- *Photograph by Investigation Unit*
